NARRATIVE END ITEM REPORT
ON SATURN S-IVB-501
(DAC S/N 1005)

AUGUST 1966
DOUGLAS REPORT SM-53184

PREPARED BY: J. W. MORRIS, ACTING
BRANCH CHIEF, QUALITY DATA AND REPORTING
RELIABILITY ASSURANCE DEPARTMENT

PREPARED FOR:
NATIONAL AERONAUTICS AND
SPACE ADMINISTRATION
UNDER NASA CONTRACT NAS7-101

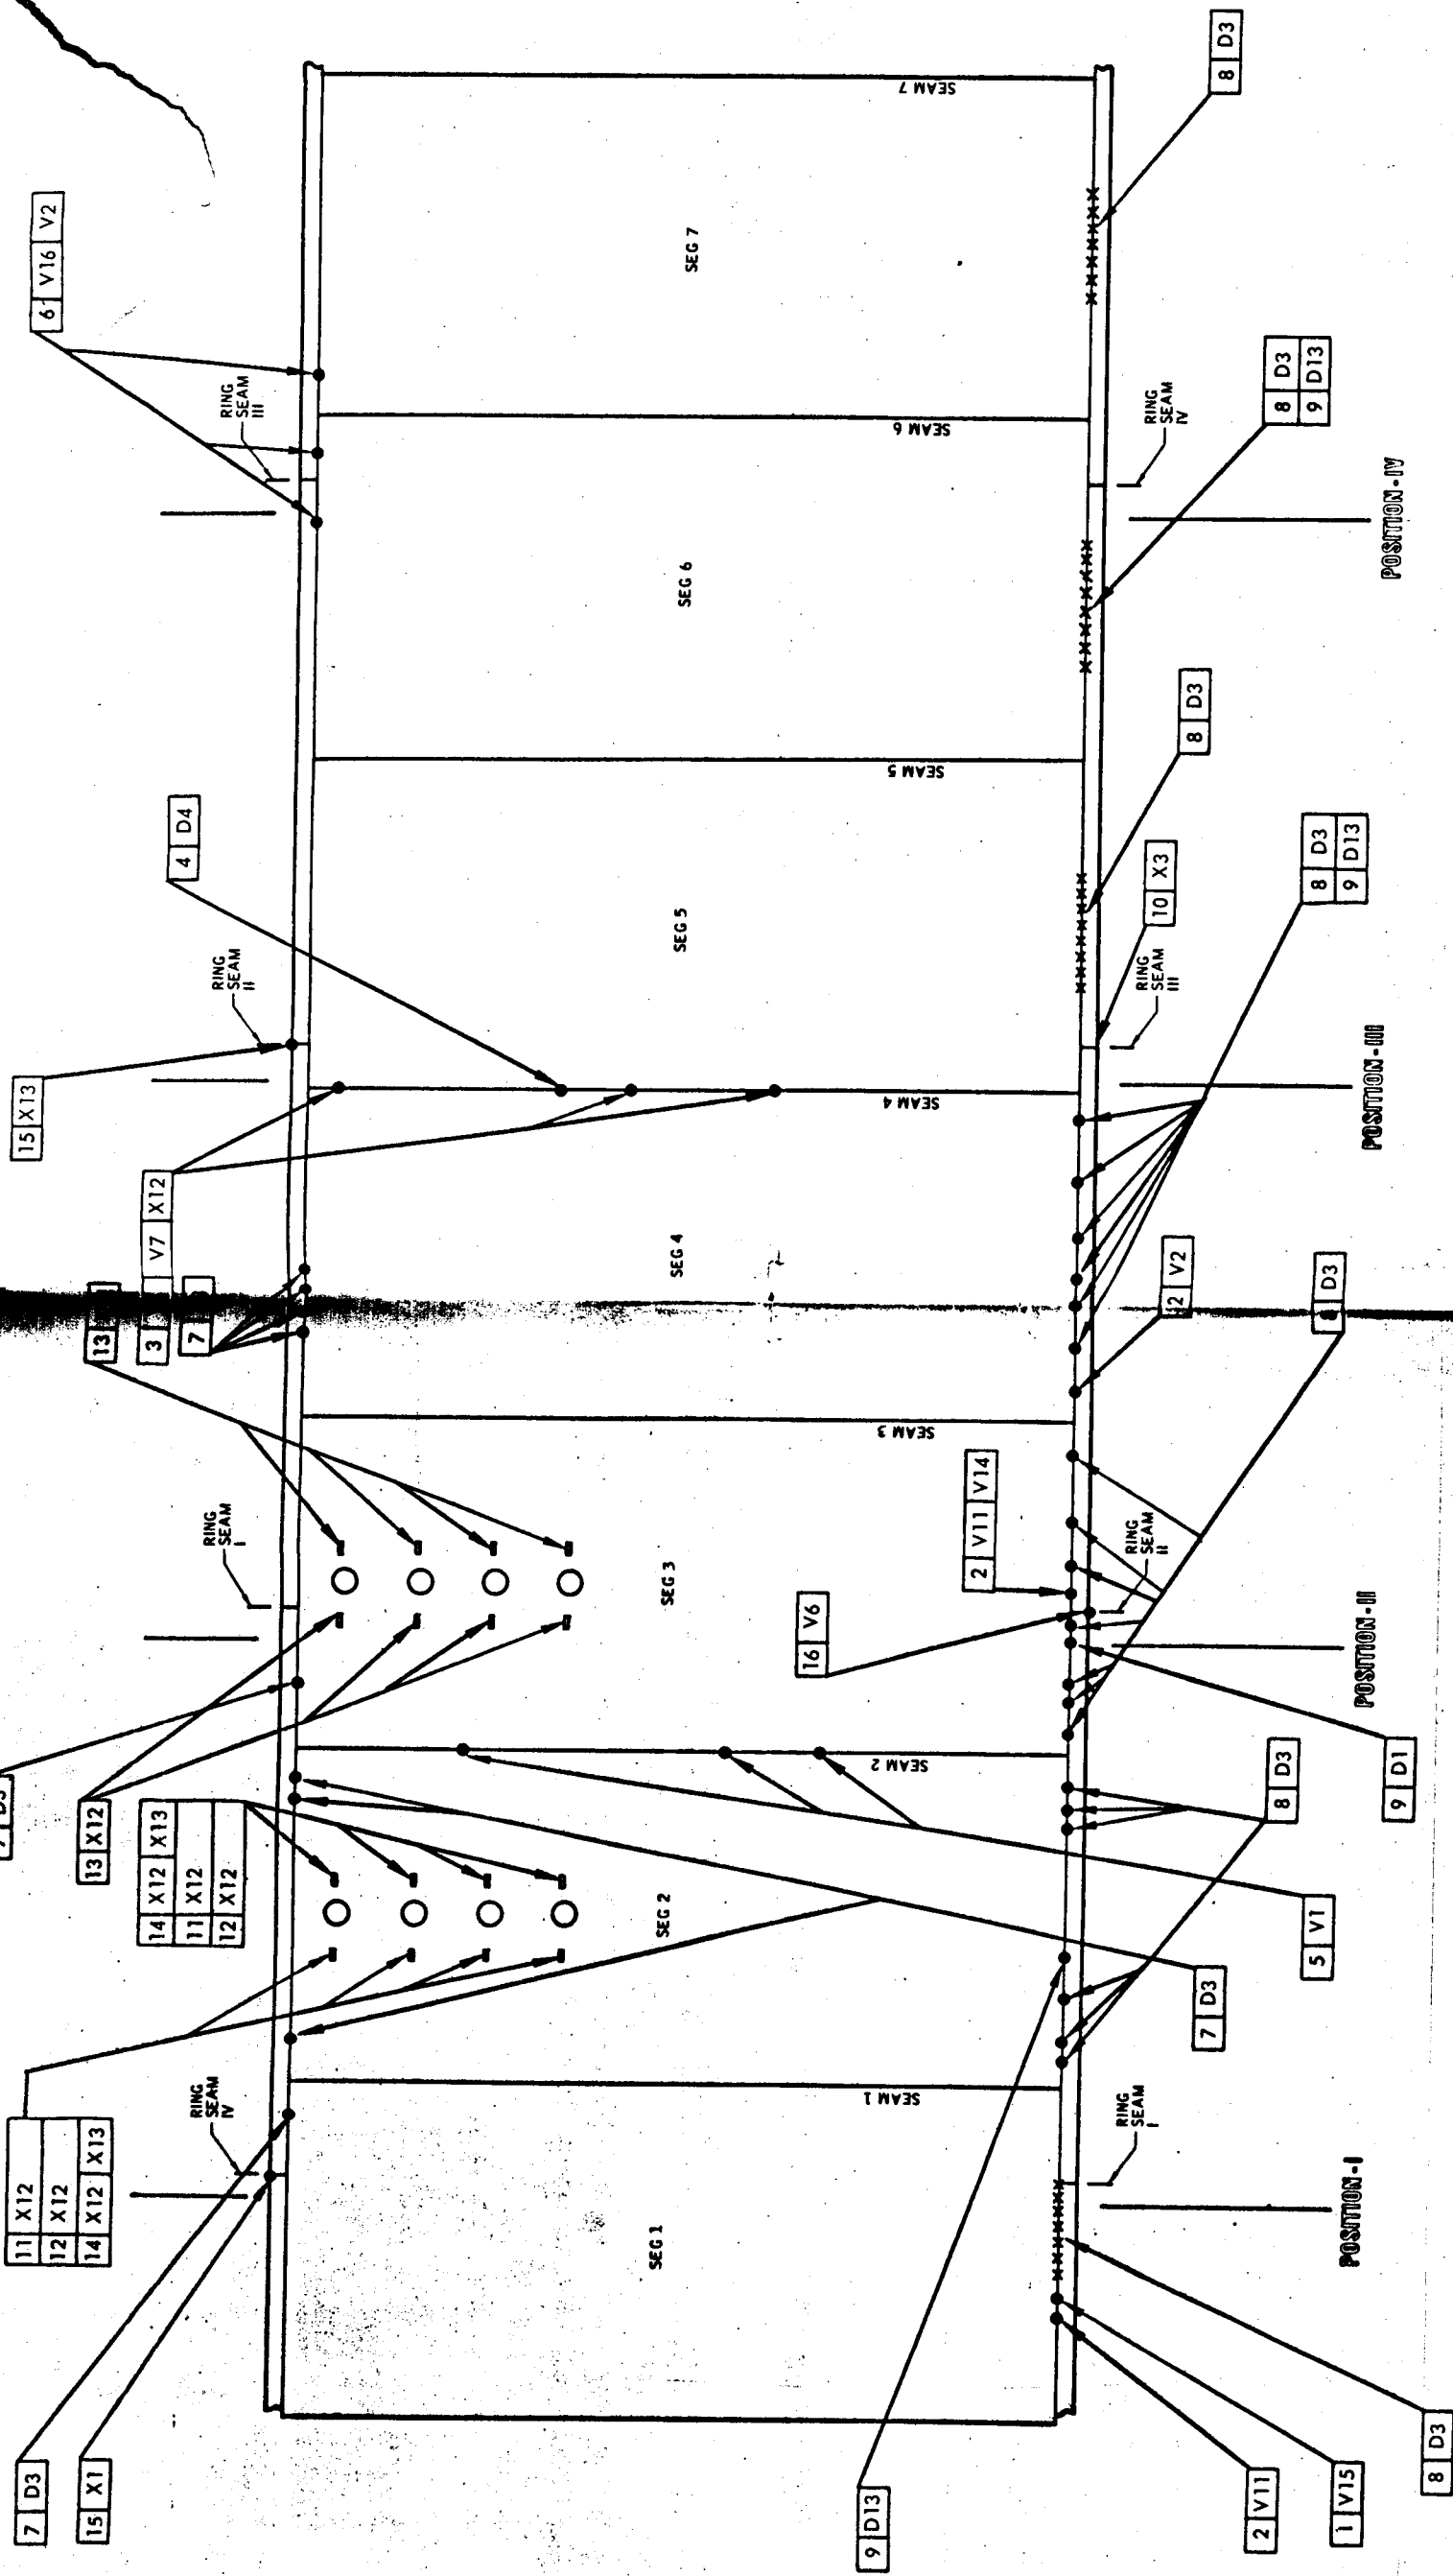
Chart 1. Forward Dome Assembly

LEGEND								
TABLE ITEM	FARR NUMBER	DATE	TOTAL DEFECTS	TYPE DEFECT	DETECTED BY	SIDE	REWORKS REQUIRED	
89	A074456	2-25-65	1	15	V	-	0	
90	A074460	2-14-65	3	14, 11, 2	V	-	1	
92	A074558	1-20-65	3	5, 2	V-X	-	3	
93	A074562	1-25-65	1	4	D	-	1	
95	A074588	1-28-65	3	1	V	I-O	2	
96	A074712	2-16-65	3	16, 2	V	-	1	
97	A074716	2-18-65	NUMEROUS	3	D	-	1	
98	A074810	2-20-65	NUMEROUS	3	D	-	1	
101	A074813	2-22-65	4	13, 1	D	O	1	
102	A113986	11-11-64	1	3	X	-	0	
103	A114000	11-21-64	8	12	X	I	0	
104	A118275	11-25-64	8	12	X	O	1	
105	A120053	11-27-64	8	12	X	I	0	
107	A120058	12-1-64		12, 13	X	-	0	
108	A120072	12-18-64	2	1, 13	X	-	2	
110	A120094	12-17-64	1	6	V	O	1

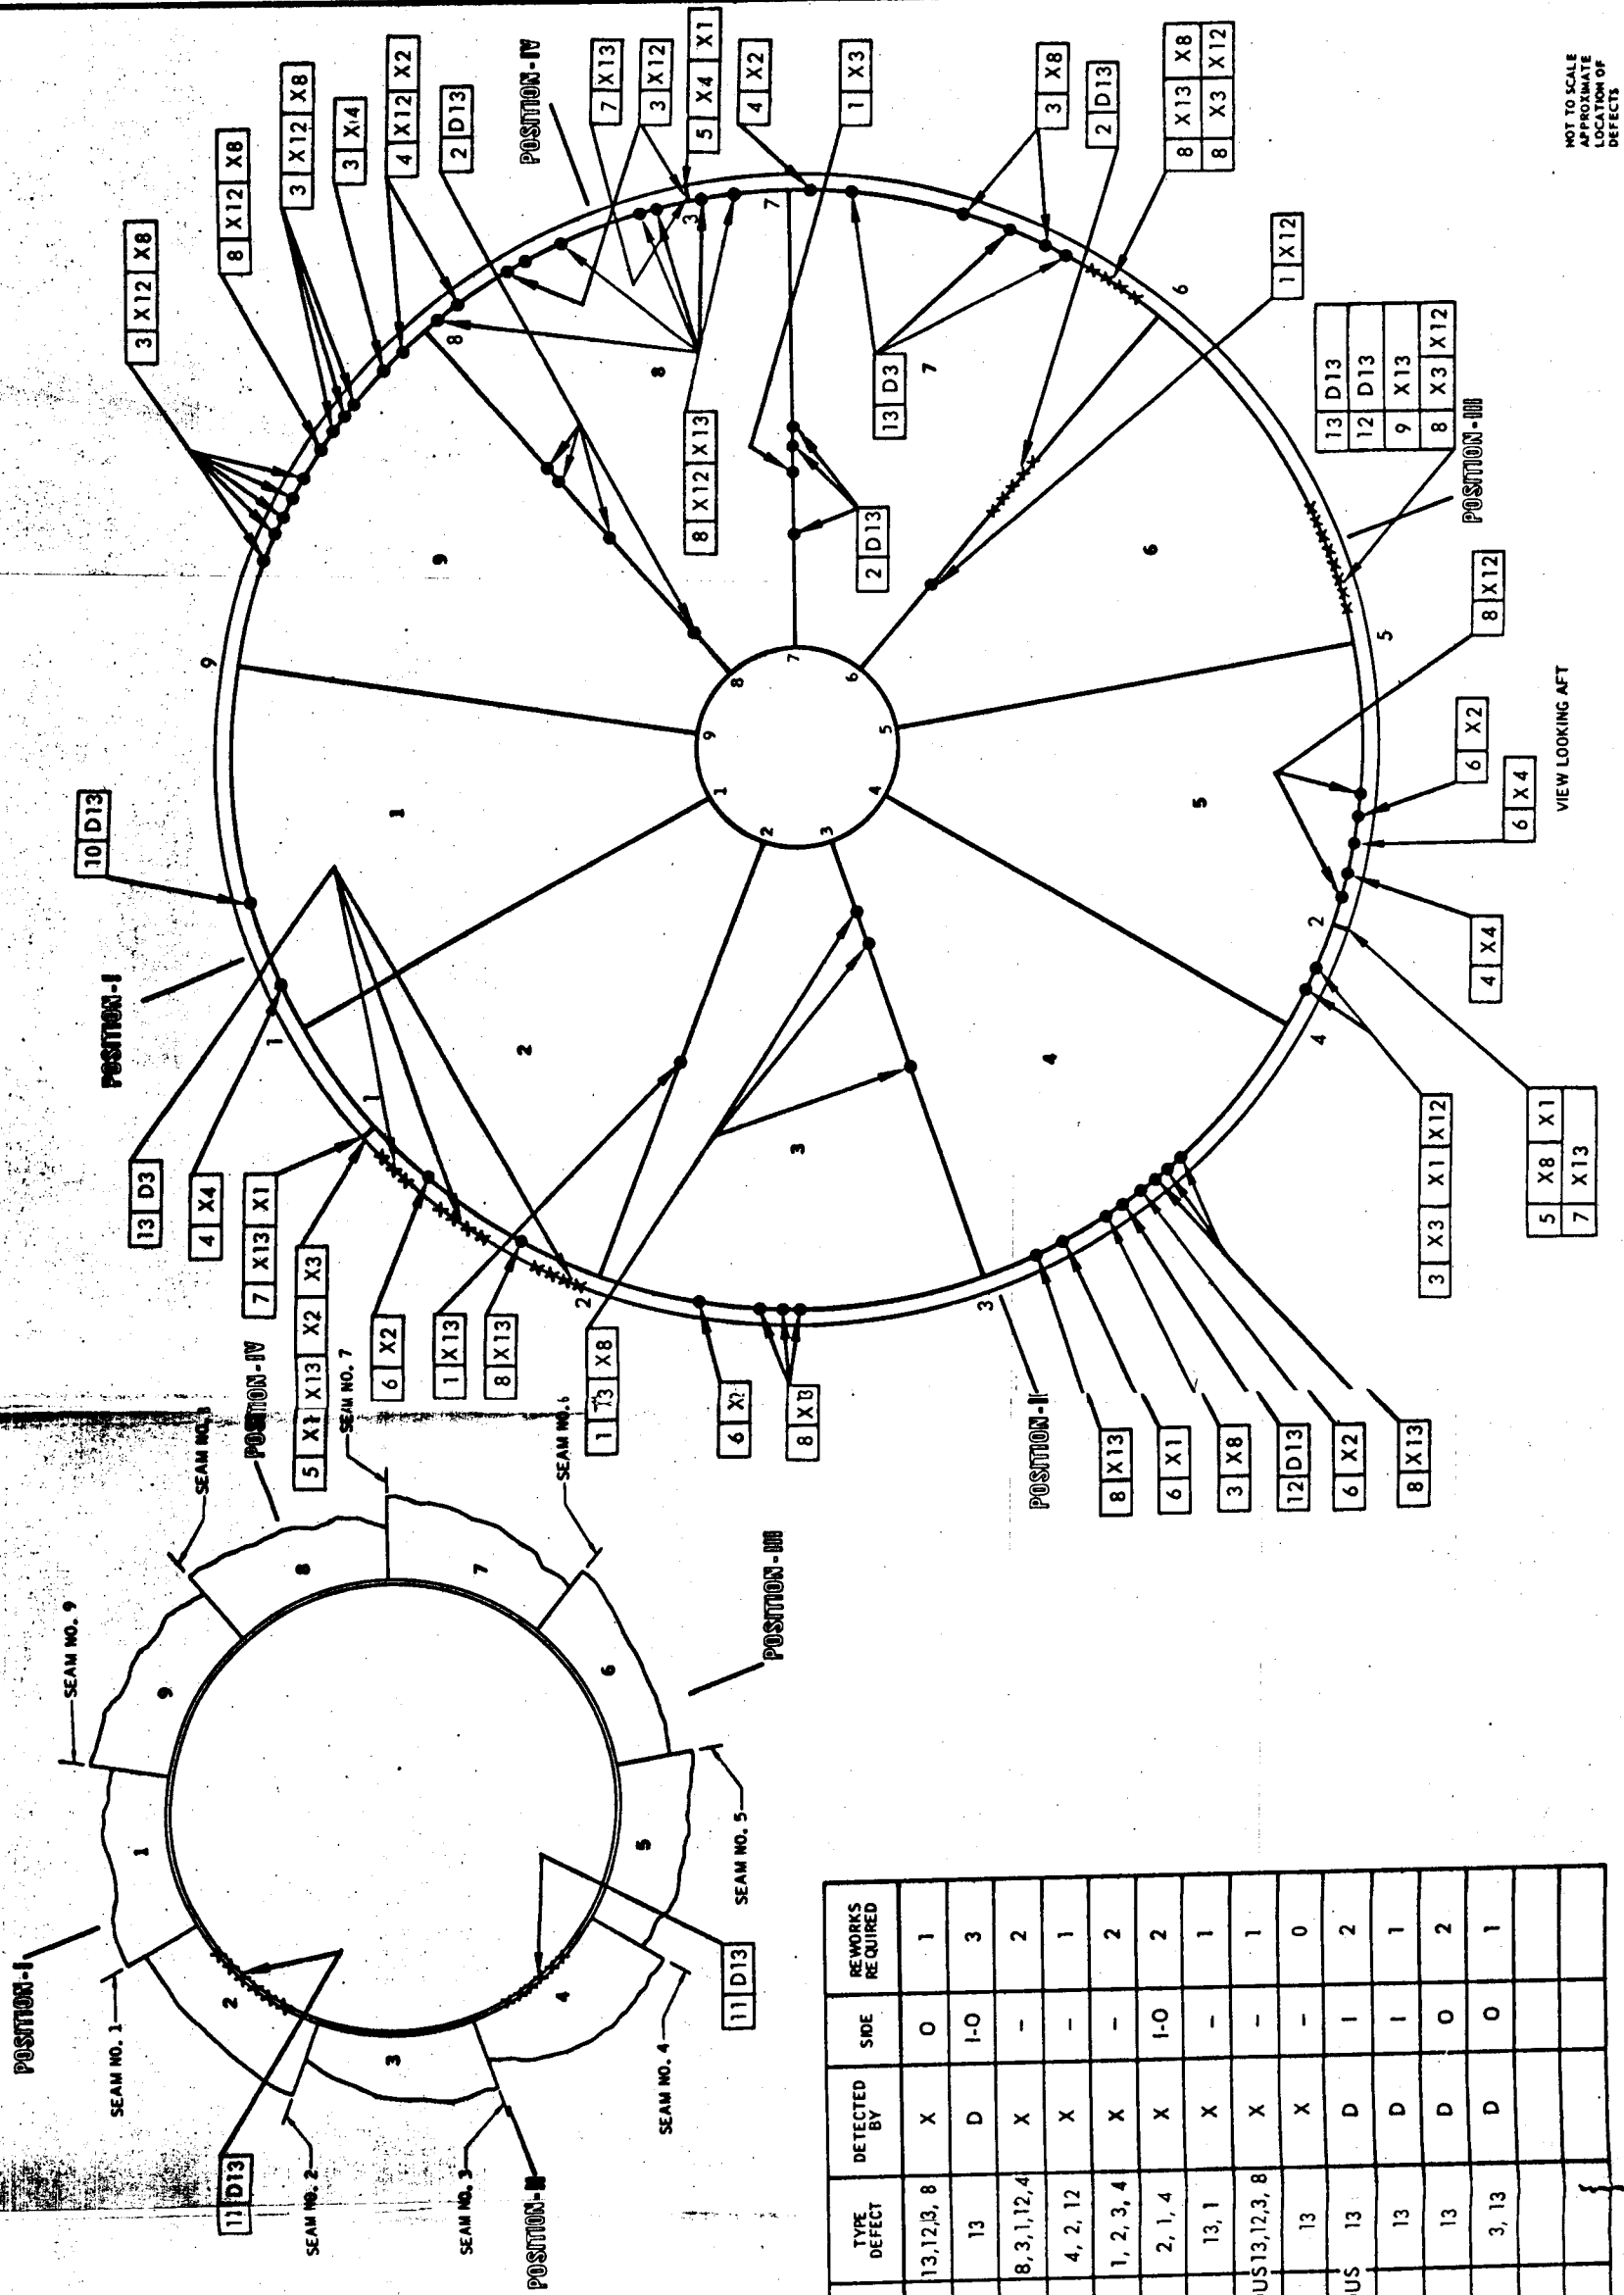
Chart 6. Aft Dome Assembly

TABLE ITEM	FARR NUMBER	DATE	TOTAL DEFECTS	TYPE DEFECT	DETECTED BY	SIDE	REWORKS REQUIRED
1	118	A099344	5	13,12,3,8	X	O	1
2	119	A099355	16	13	D	I-O	3
3	121	A099393	22	8,3,1,12,4	X	-	2
4	122	A099406	6	4,2,12	X	-	1
5	123	A099453	6	1,2,3,4	X	-	2
6	124	A099465	8	2,1,4	X	I-O	2
7	125	A099472	3	13,1	X	-	1
8	138	A113941	NUMEROUS	13,12,3,8	X	-	1
9	139	A113952	1	13	X	-	0
10	140	A113953	NUMEROUS	13	D	I	2
11	145	A113983	2	13	D	I	1
12	153	A118273	5	13	D	O	2
13	155	A120057	11	3,13	D	O	1
14							
15
